Ref: Emerson Place Subdivision  
Notice of Intent

I am writing to provide a revised subdivision plan, which addresses comments received during the permitting process and the Town's peer review consultant. In addition to a revised subdivision plan and stormwater report, the following items are attached to this letter;

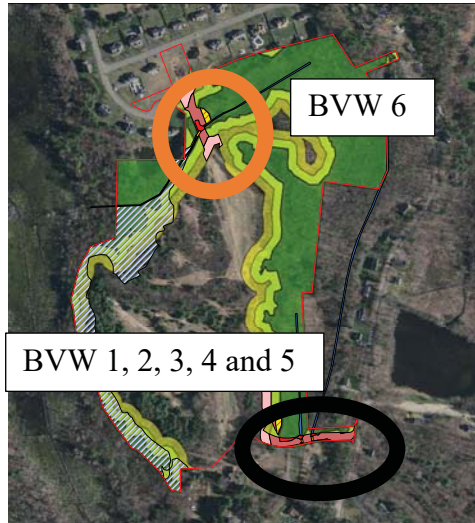
**Map 2:** BVW impact areas 1 through 5 can be found in the black circle at the southeastern portion of the site. BVW 6 can be found in the orange circle at the northern portion of the site.

Existing conditions for all BVW impact areas were evaluated and described in this report. **Map 2** shows the general locations of each BVW on this site.

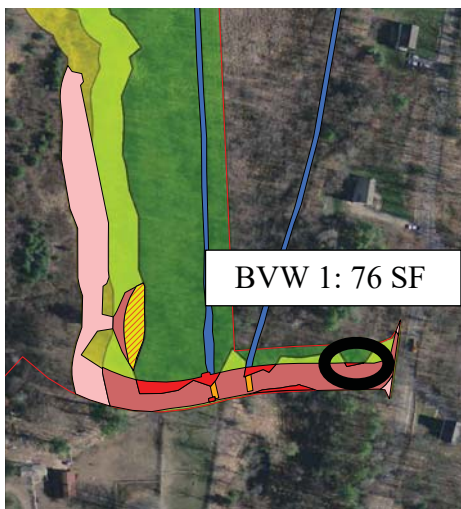
**Map 3:** BVW 1 is shown as a bright red area within the black circle.

BVW Impact Area 1 (76 SF: 14 SF wetland fill, 62 SF temporary disturbance) is located at the southeast section of the site between wetland flags WF B168 and WF B166 which can be accessed from a gravel path off of Ridge Street. The following list of vegetation is provided with each species' respective percent cover of the area: glossy buckthorn (90%), red maple (75%), quaking aspen (35%), silky dogwood (15%), white pine (15%), sensitive fern (10%), elm (5%), moss (5%), and poison ivy (2%), white ash (2%), burning bush (2%). There are significant amounts of downed woody debris scattered on the forest floor. The BVW's hydric soils are a

fine sandy loam, show signs of redox at 6" below the surface, and ground water appears 14" below. BVW 1 is shown on **Map 3** and **Photo 1** shows the existing conditions.

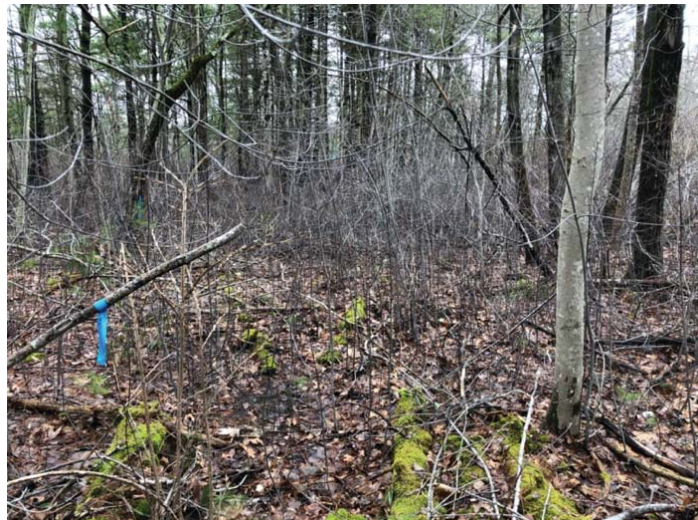
**Photo 1:** Existing conditions of BVW 1.

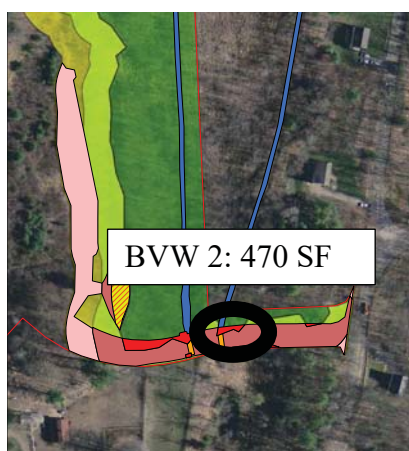
**Map 4:** BVW 2 is shown as a small, bright red area within the black circle.

BVW Impact Area 2 (470 SF: 324 SF wetland fill, 146 SF temp. disturbance) is located at the southeast section of the site between wetland flags WF B162 and WF BB2 and is adjacent to Stream 1, which can be accessed from the gravel road off of Ridge Street. The following list of vegetation is provided with each species' respective percent cover of the area: white pine (60%), red maple (50%), glossy buckthorn (45%), highbush blueberry (30%), sugar maple (25%), elm (5%), sensitive fern (5%), and burning bush (5%). The BVW's hydric soils are a fine sandy loam and redox is evident 2' below the surface. The top 20" of soil is dark muck (10YR 1/2) and transitions to depleted soils (5YR 7/2) by 24" below. BVW 2 is shown on **Map 4** and **Photo 2** shows the existing conditions.

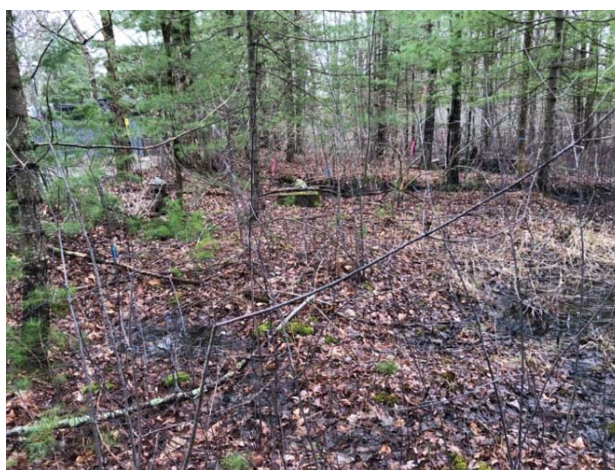
**Photo 2:** Existing conditions of BVW 2.

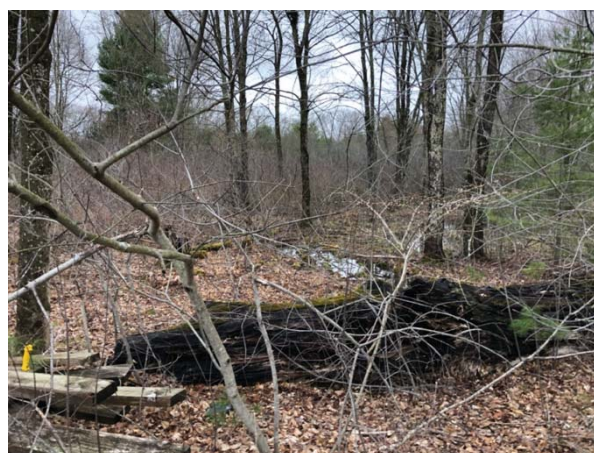
**Photo 3:** Existing conditions of BVW 3.

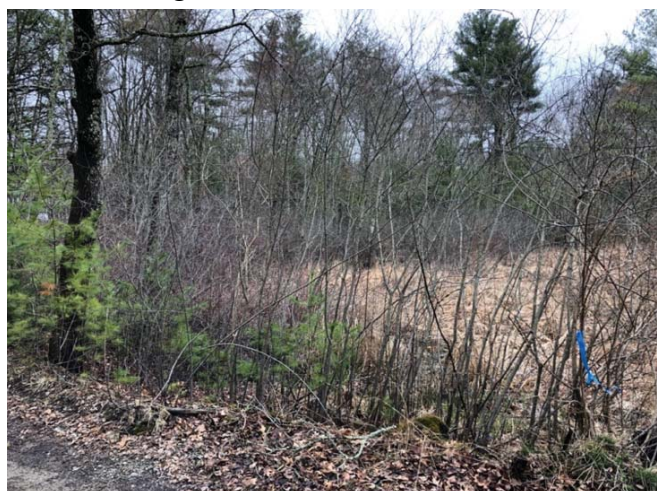
**Photo 4:** Existing conditions of BVW 4. The gravel path can be seen at the bottom left corner of the photo.

accessed from the gravel road off of Ridge Street. The following list of vegetation is provided with each species' respective percent cover of the area: cattails (65%), silky dogwood (30%), white pine (20 %), glossy buckthorn (20%), red maple (10%), red oak (5%), rush (5%), elderberry (5%), highbush blueberry (5%), black cherry (5%), sensitive fern (5%), and burning bush (5%). The BVW's hydric soils are inundated and consist of several inches of muck and depleted soils below (5YR 7/2). BVW 4 is shown on **Map 6** and **Photo 4** shows the existing conditions.

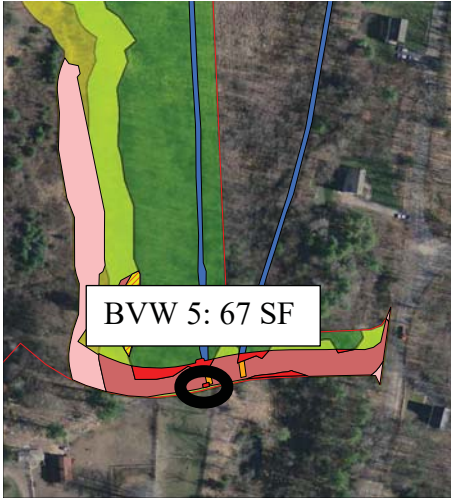
**Map 7:** BVW 5 is shown as a bright red area within the black circle.

BVW Impact Area 5 (67 SF: 35 SF wetland fill, 32 SF temp. disturbance) is located at the southeast section of the site. The area is across the existing gravel path, south of wetland flag WF B158; the area itself is not flagged. The majority of the vegetation in the area consists of lawn with a few shrubs growing on a small slope up to the gravel path. BVW 5 is shown on **Map 7** and **Photo 5** shows existing conditions.

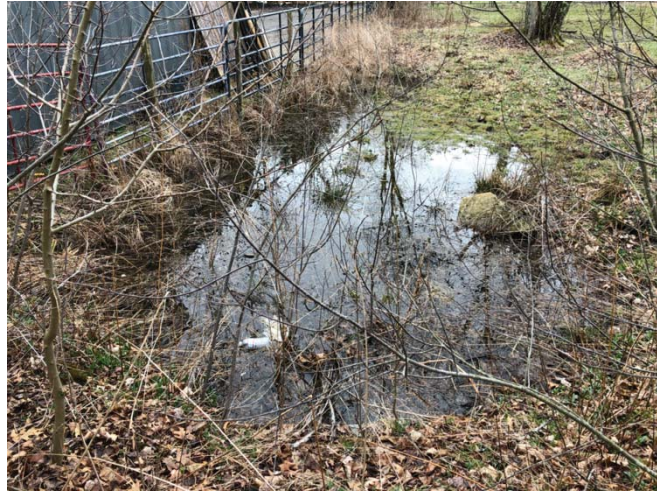
**Photo 5:** Existing conditions of BVW 5. The photo was taken from the gravel path. Wetland flag B158 is hung directly across the gravel path.

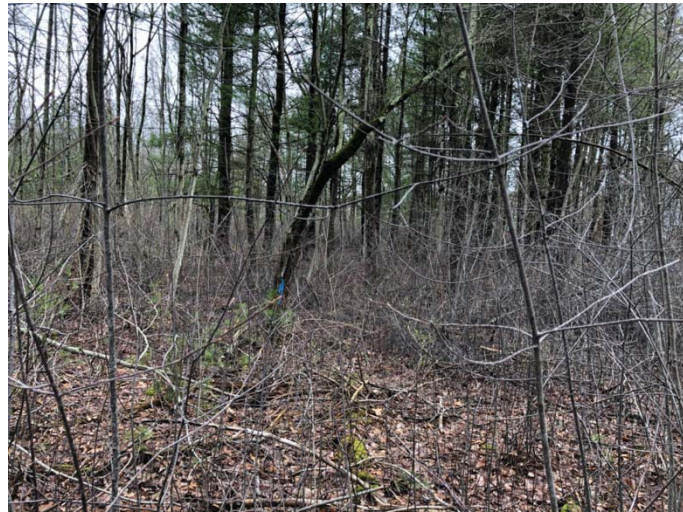
**Photo 6:** Existing conditions of BVW 6.

maple (30%), white pine (30%), silky dogwood (30%), Arrowwood (20%), crabapple (10%), black cherry (5%), sensitive fern (5%), skunk cabbage (5%). The BVW's hydric soils consists of 6' of muck and depleted soils below (5YR 6/2). BVW 6 is shown on **Map 8** and **Photo 6** shows the existing conditions.

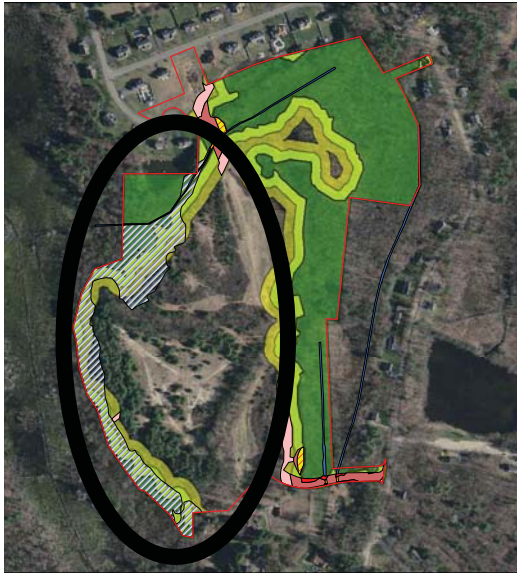
**Map 10:** BLSF is present in the western portion of the site and can be seen as a blue and white hatched area inside of the black circle.

Portions of the westerly side of the site fall within a FEMA Zone A Flood Plain for the Great Black Swamp. While there is no FEMA elevation established, the subdivision plans presume that the 100-year flood elevation is 142.9. The BLSF boundary lies within wooded areas in the westerly portions of the site and is proposed to be impacted in a single instance. 100 SF of BLSF will be impacted for streambed restoration purposes during the stream crossing construction. No BLSF will be filled. The extent of BLSF can be seen on **Map 9** and the BLSF impact area can be seen in **Map 10**.

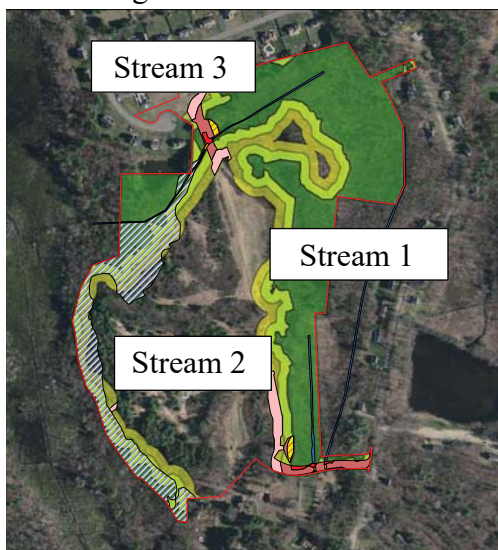
**Map 11:** Stream 1 is the southeastern most stream, Stream 2 is the southwestern most stream, and Stream 3 is the northern most stream.

Existing conditions for the Banks of three streams were evaluated and described below. **Map 11** shows the general locations of each stream on site and their associated banks:

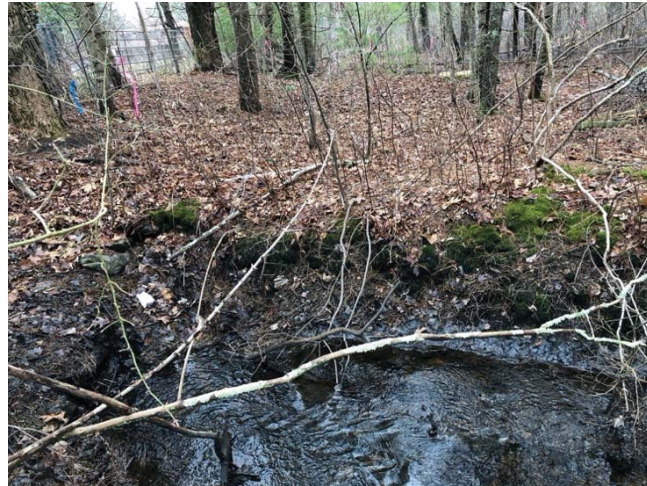
**Photo 7:** The existing conditions of the west Bank to Stream 1. The gravel road is not shown in this photo, yet it is just left of this point of view.

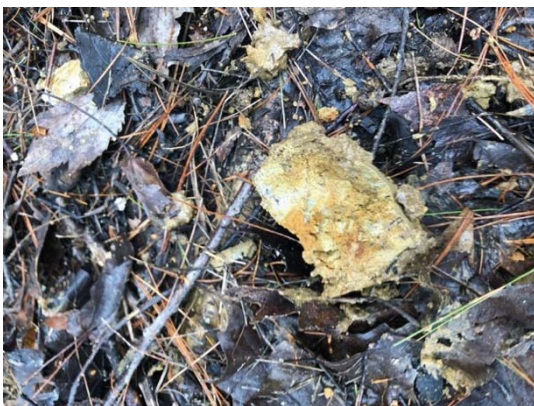
**Photo 8:** More than 8 inches below the surface of Stream 1's Banks, the soils are depleted (7.5YR 6/2) and contain 80% redoximorphic features (7.5YR 6/8).

litter, and the roots of several species of plants. The following list of vegetation is provided with each species' respective percent cover of the area: white pine (60%), red maple (50%), glossy buckthorn (45%), highbush blueberry (30%), sugar maple (25%), elm (5%), sensitive fern (5%), and burning bush (5%). See **Photo 7** for existing conditions. The Bank's substrate consists of four inches of muck (10YR 2/1), which transitions to a brown A-horizon (7.5YR 3/4) between 4 and 8 inches. More than 8 inches below, the C-horizon is depleted (7.5YR 6/2) and contains 80% redoximorphic features (7.5YR 6/8). See **Photo 8** for soil conditions. Stream bed material

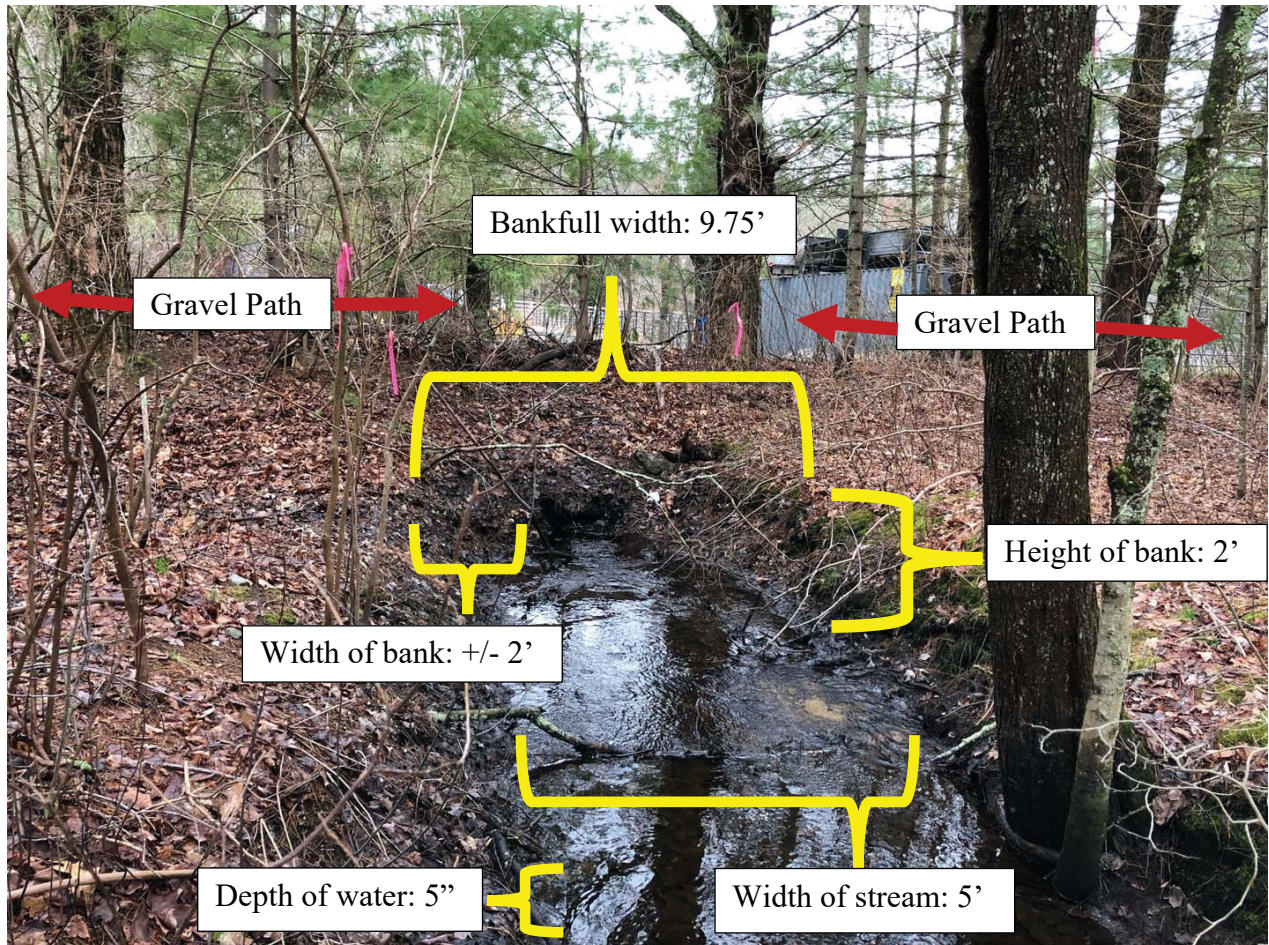
Average (Avg.) Width of banks:	+/- 2' (variable)
Avg. height of banks:	2'
Avg. bankfull width:	9.75'
Avg. depth of water:	5" (variable...measurement taken 2/25/2020)
Avg. width of stream:	5'

**Photo 9:** The dimensions of Stream 1 and its Banks. Brackets demarcate the general boundaries of each measurement (not drawn to scale). Stream 1 is flowing toward the gravel path and into a culvert in the center of the image.

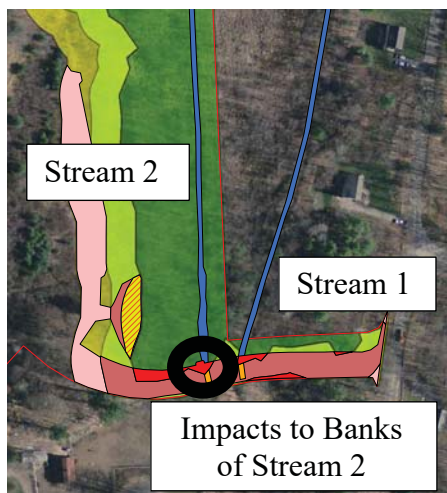
**Map 13:** Banks of Stream 2 are located at the head of Stream 2, shown within the black circle.

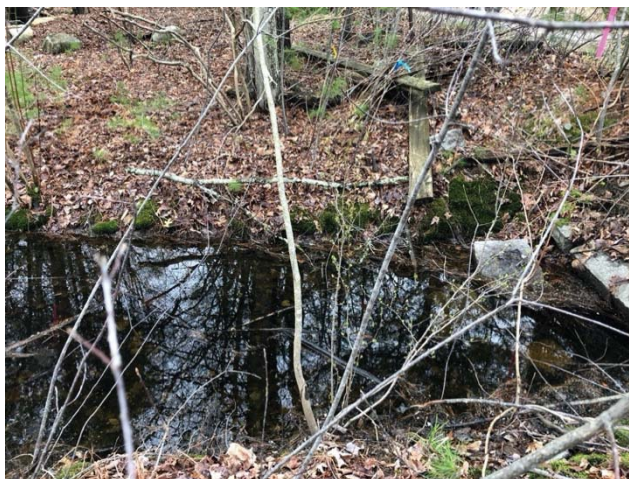
**Photo 10:** The existing conditions of Stream 2 and its east Bank.

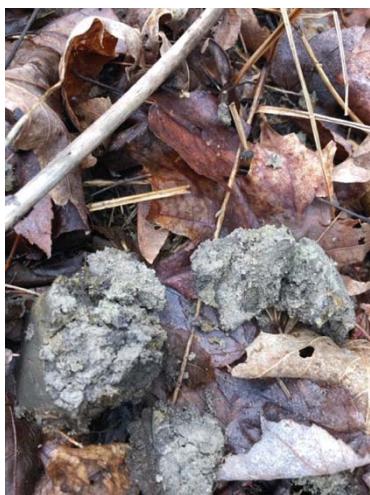
**Photo 11:** More than 16 inches below the surface of Stream 2's Banks, the C-horizon is depleted (7.5YR 6/1) and contains 5% redoximorphic features (7.5YR 6/6).

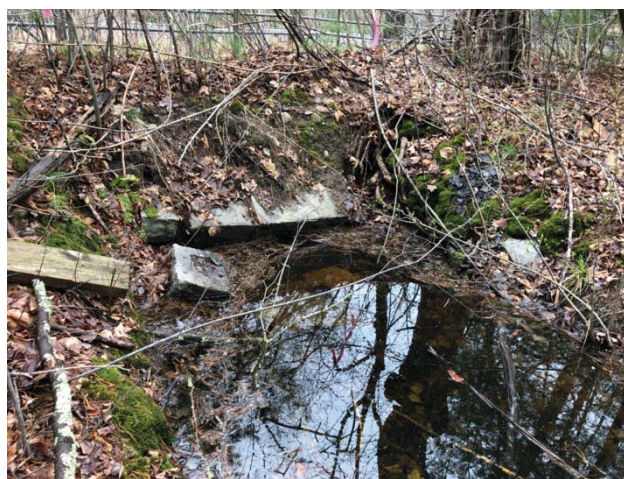
**Photo 12:** The entrance to the culvert is blocked by caved in large granite slabs and organic debris.

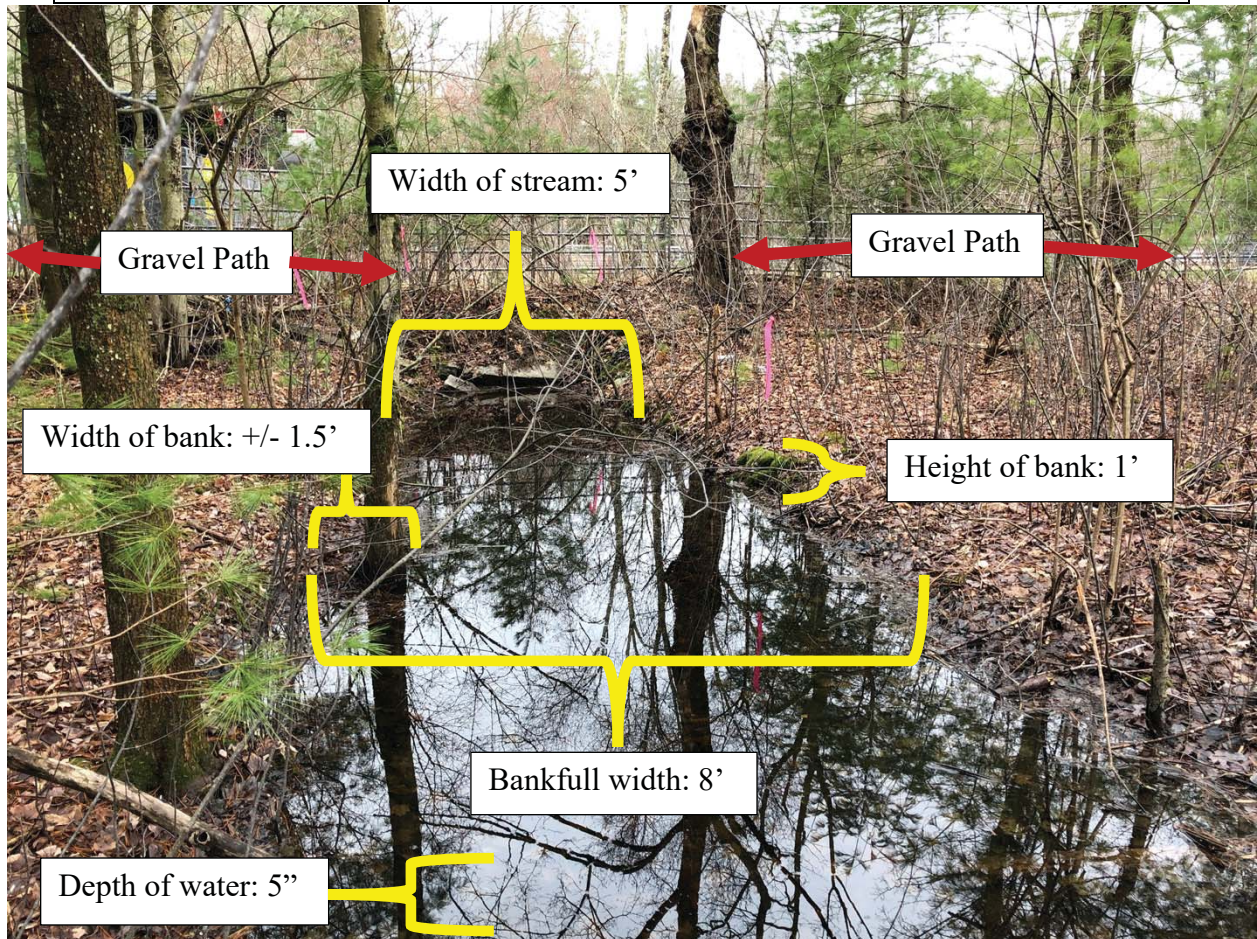
Avg. width of banks:	+/- 1.5' (variable)
Avg. height of banks:	1'
Avg. bankfull width:	8'
Avg. depth of water:	5" (variable...measurement taken 2/25/2020)
Avg. width of stream:	5'

**Photo 13:** The dimensions of Stream 2 and its Banks. Brackets demarcate the general boundaries of each measurement (not drawn to scale). Stream 2 is flowing toward the gravel path and into a culvert in the center of the image.

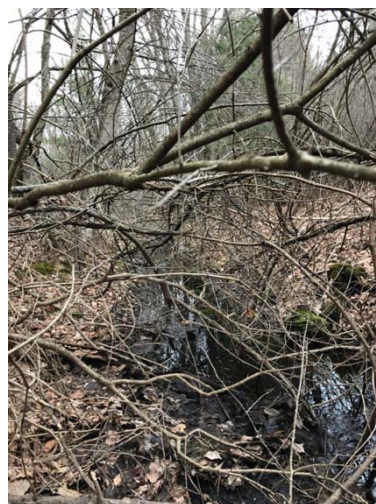
**Photo 14:** Dense shrub vegetation overhangs Stream 3 and its Banks.

The Banks of Stream 3 are visible from an existing gravel road, 480 feet from Rolling Meadows Drive. The stream crossing location is between wetland flags WF H3-H1 and WF HH1-HH4. See **Map 14** for the location of the Banks of Stream 2. Banks are secured by moss, leaf litter, rocks, and the roots of several species of plants. The following list of vegetation is provided with each species' respective percent cover of the area: glossy buckthorn (60%), multiflora rose (50%), red maple (30%), white pine (30%), silky dogwood (30%), Arrowwood (20%), crabapple (10%), black cherry (5%), sensitive fern (5%), skunk cabbage (5%). This vegetation is dense and hangs over the stream, creating shady conditions (see **Photo 14** for the

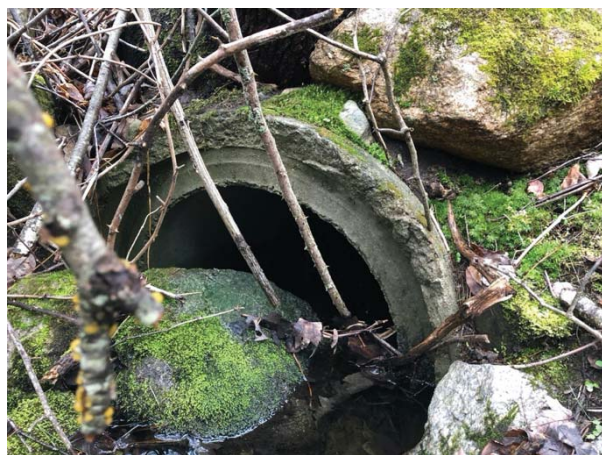
**Photo 14:** Stream 3 enters a two-foot diameter pipe culvert between flags B H1 and B H2.

large rocks (1' diameters) and an organic layer of leaves, twigs, and small woody debris, with layers of muck and gravel beneath. Banks connect to the edge of the gravel road and the stream diverts into an underground culvert (2' wide) which passes to the other side of the gravel road and continues downstream (see **Photo 14** and **Photo 15** for a view of the culverts). Bank and stream data are listed in **Table 3** below for easy reference. **Photo 16** creates a clear view of how the dimensions were measured.

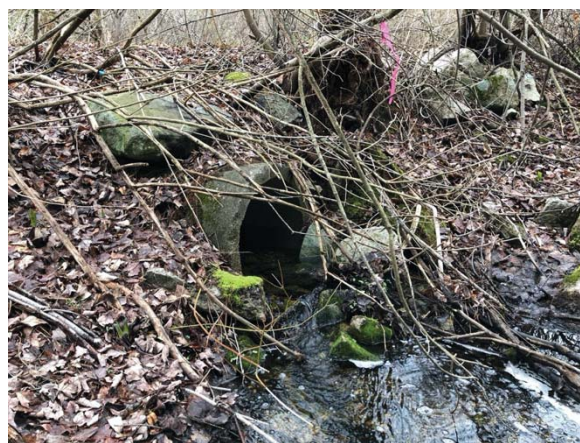
**Photo 15:** Stream 3 exits a culvert at flag WF D8 and flows to the western portion of the site, eventually reaching the Great Black Swamp on the adjacent property.

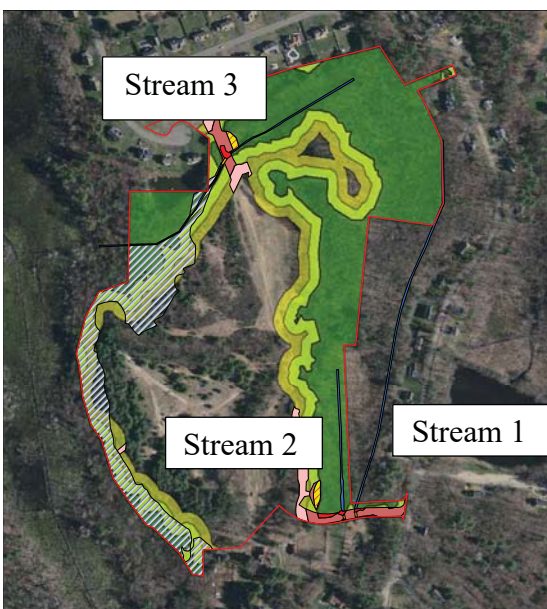
**Map 15:** Stream 1, Stream 2 and Stream 3 are labeled on the map.

Documented field observations showed that each stream was not flowing, qualifying each stream as intermittent. Field observations were made by competent sources. Goddard Consulting, LLC observed Streams 1, 2, and 3 not flowing on September 25<sup>th</sup> and October 4<sup>th</sup>, 5<sup>th</sup>, 6<sup>th</sup>, and 7<sup>th</sup> of 2017 (see **Map 15**).

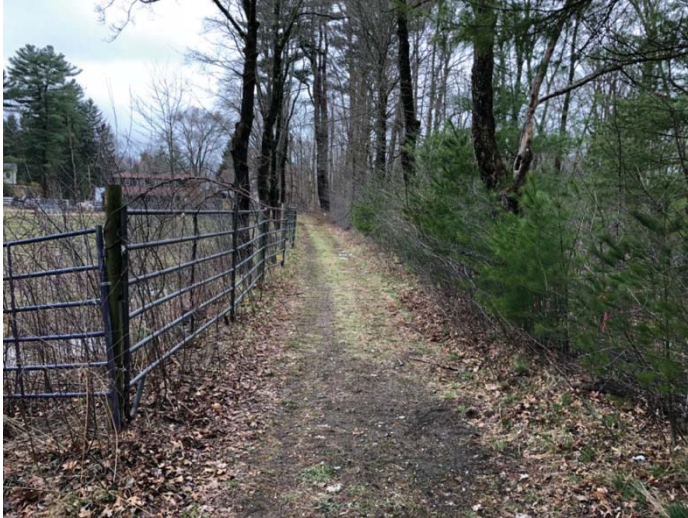
**Photo 17:** The existing gravel path that runs from the southern Ridge Street entrance to the upland portion of the site. BVW 3 can be seen on the right side of the path. A fenced-in field with horses can be seen to the left.

To minimize impacts to BVW and associated BVW Buffer Zones, road construction is proposed on the same footprint as existing gravel paths. Gravel paths off of the Rolling Meadow Drive and southern Ridge Street entrances allow pedestrians and small automobiles to access the upland portion of the site. **Photo 17** and **Photo 18** show the gravel paths at the southern Ridge Street entrance and the Rolling Meadow Drive entrance, respectively. **Map 18** and **Map 19** show the southern Ridge Street entrance and the Rolling Meadow Drive entrance, respectively, with a black arrow representing the general location of each existing gravel path. The gravel paths are narrow and currently do not provide a safe means of accessing the site. In order for a larger automobile or heavy equipment to safely enter the upland portions of the site, paved roads must be constructed through BVW. The minimum allowed width of a road approved by the Millis Planning Board is 50 feet, making BVW impacts unavoidable at each available entrance. The best alternative then becomes the option which proposes the least amount of impact to the BVW. Using existing gravel paths as the proposed roadways is the most reasonable alternative. This will reduce impacts to BVW significantly more than if a new roadway were constructed at the alternative northern Ridge Street entrance.

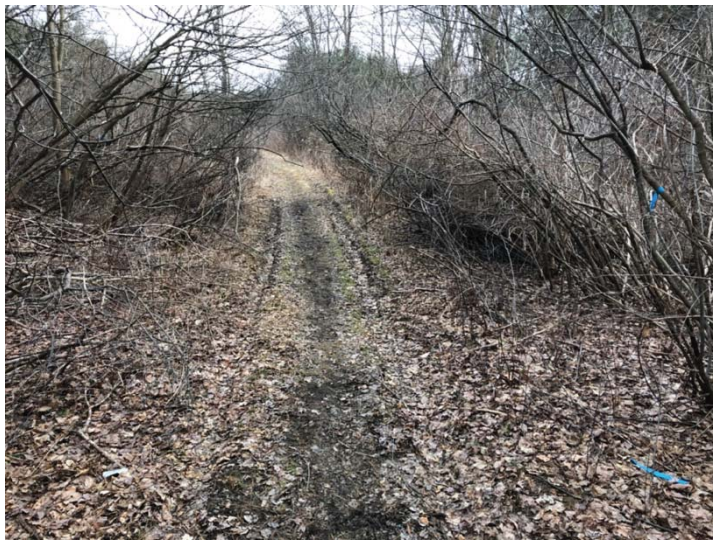
**Photo 18:** The Paddock Lane and Rolling Meadow Drive entrances have an existing gravel path that crosses BVW to reach the uplands.

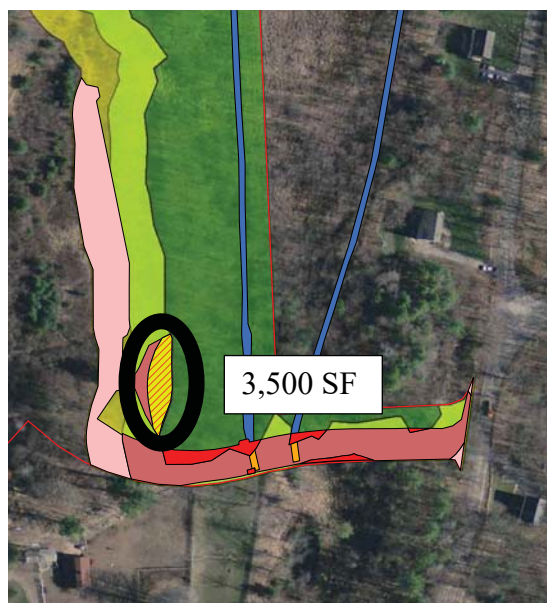
**Map 21:** Wetland Replication Area 1 is located by the southern Ridge Street Entrance. It can be seen in the black circle as a yellow and red hatched area.

To satisfy the replication area criteria set forth under the WPA, the proposed replication areas are hydrologically connected to the wetlands that the lost ones were connected to (see **Map 21** and **Map 22**). Replication Area 1 is dominated by large specimens of sugar maple and Norway maple. The understory is dominated by glossy buckthorn, white pine, crabapple and Norway maple saplings. Ground cover consists of cinnamon fern and moss. Oriental bittersweet is present but insignificant in size and percent cover. Surface elevations range from 144 to 146. Soil conditions in this area show a Munsell color of 7.5YR 5/3 at depths deeper than 1 foot with 15% redox forming around 16 inches deep (7.5YR 5/8). These hydric soil conditions are promising signs that Replication Area 1 will be a success. **Photo 19** shows the existing conditions of Replication Area 1.

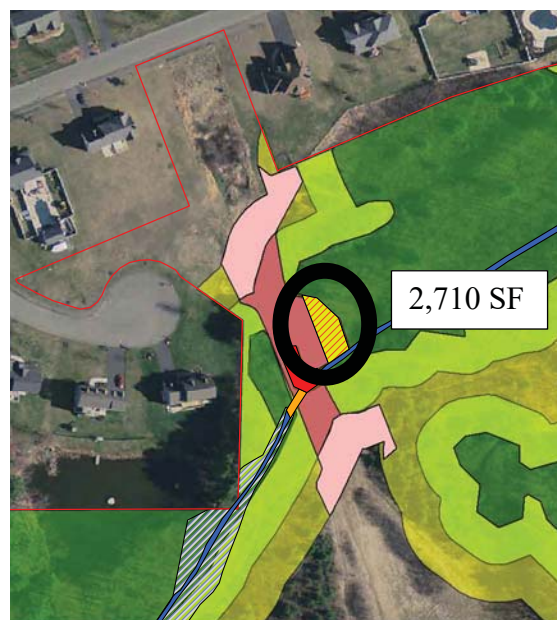
**Map 22:** Wetland Replication Area 2 is located by the Rolling Meadow Drive entrance. It can be seen in the black circle as a yellow and red hatched area.

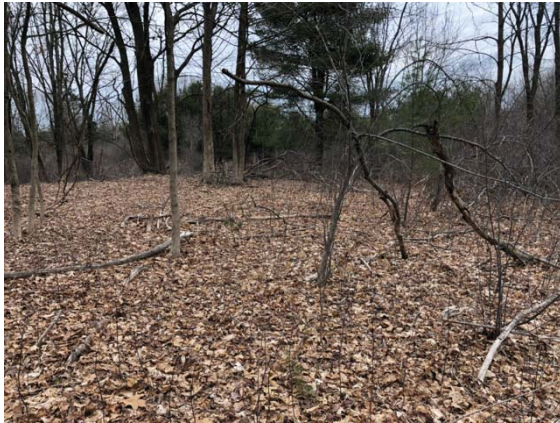
**Photo 19:** The existing conditions of Replication Area 1.

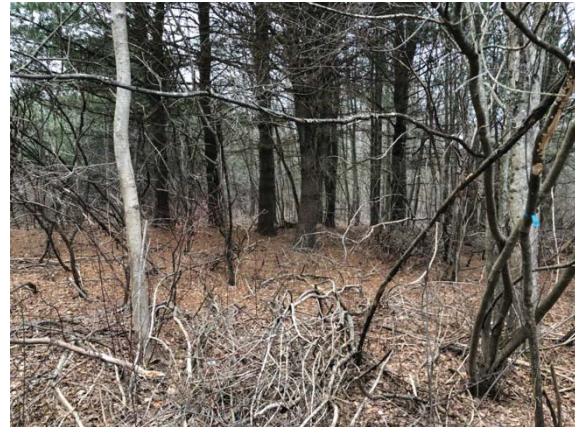
**Photo 20:** The existing conditions of Replication Area 2.

Replication Area 2 is dominated by large specimens of white pine and red maple. The understory is dominated by diseased glossy buckthorn and red maple saplings. Ground cover is sparse but contains cinnamon fern and moss. Grape vines are present on the white pine trees. Surface elevations range from 146 to 150. Soil conditions in this area show a Munsell color of 10YR 6/4 at depths deeper than 2 feet with redox forming around 28 inches deep. **Photo 20** shows the existing conditions of Replication Area 2.

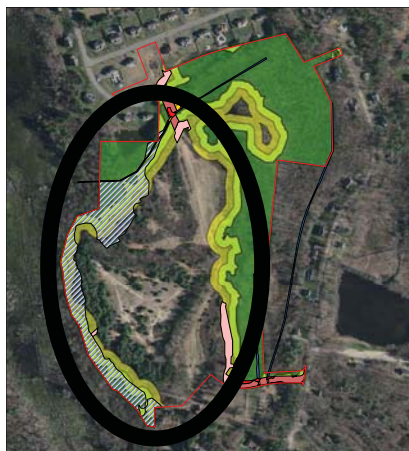
**Map 23:** BLSF is present in the western portion of the site and can be seen as the blue and white hatched area inside of the black circle.

Portions of the westerly side of the site fall within a FEMA Zone A flood plain for the Great Black Swamp. There is only one instance where BLSF impacts will occur. At the stream crossing at Stream 3, a pipe culvert will be removed from an existing gravel road. Portions of the existing culvert lie outside of the proposed box culvert footprint. Thus, about 30 LF of new bank will be replicated in the previously degraded cart path footprint which lies in BLSF. This area will be restored to natural conditions including flow and substrate material. Impacts are negligible in square footage (+/- 100 SF) and will not require volumetric additions. The overall extent of BLSF can be seen on **Map 23** and the BLSF impact area can be seen in **Map 24**. No BLSF area will be lost so there is no need to mitigate for the impacts.

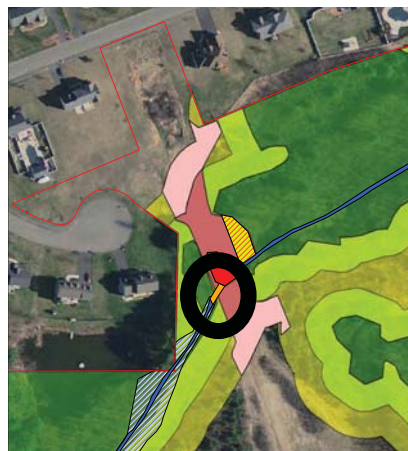
**Map 24:** The BLSF impact will take place in the Stream 3 restoration area, shown as the orange area within the black circle.

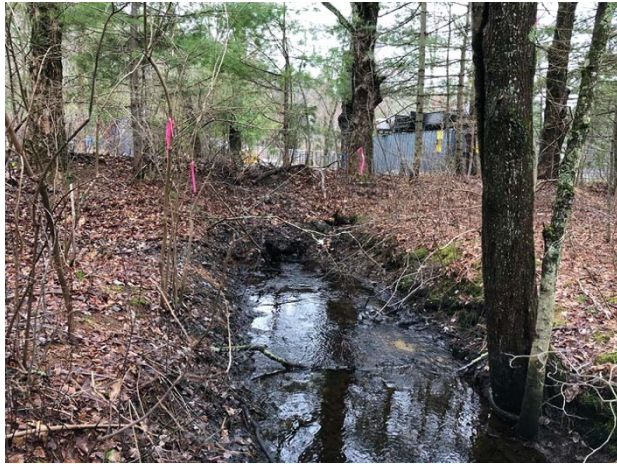
**Photo 21:** The Banks of Stream 1 are seen here merging with the gravel path which the stream flows under.

In total, 125 LF of Bank is proposed to be permanently lost: 50 LF of Stream 1, 44 LF of Stream 2, and 31 LF of Stream 3. At Streams 1 and 2, the existing culvert openings are ~3 feet wide and ~8" tall and are covered with debris, restricting flow. The box culverts will replace the existing culverts and will be sized according to the criteria in the stream crossing standards. **Map 25** shows the location of these Bank impacts and **Photo 21** and **Photo 22** show the existing conditions of the Banks. At Stream 3, the existing culvert is 24" in diameter and has restricted flow due to numerous rocks placed at the upstream opening. Similarly, the box culvert will replace the existing pipe culvert and will be sized according to the criteria in the crossing standards. Portions of the existing culvert lie outside of the proposed box culvert footprint. Thus, about 30 SF of new bank will be replicated in the previously degraded cart path footprint. **Map 26** shows the location of these Bank impacts and **Photo 23, 24, and 25** show the existing conditions of the Banks and culverts.

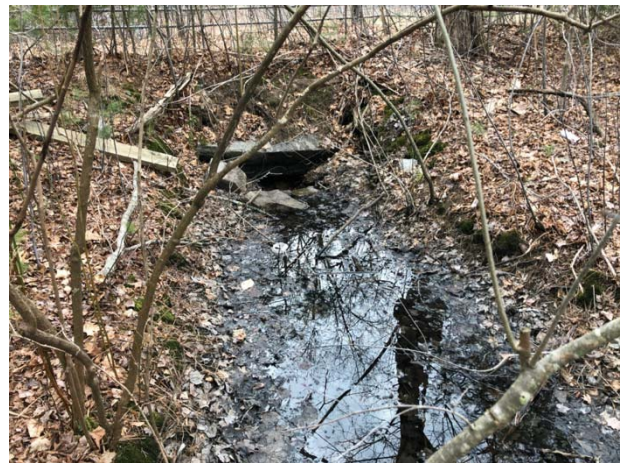
**Photo 22:** The banks of Stream 2 can be seen merging with the gravel path which the stream flows under.

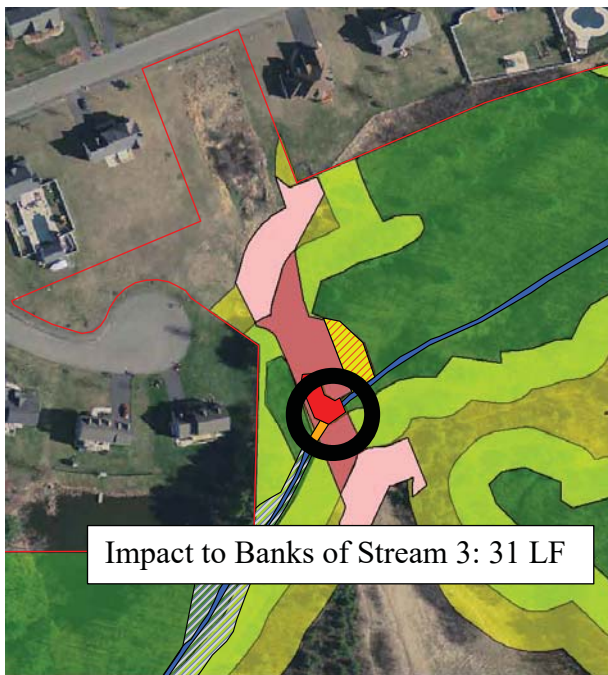
**Map 26:** Bank impacts will take place where Stream 3 enters a culvert under the gravel path. Bank impacts will be consolidated to the area in the black circle.

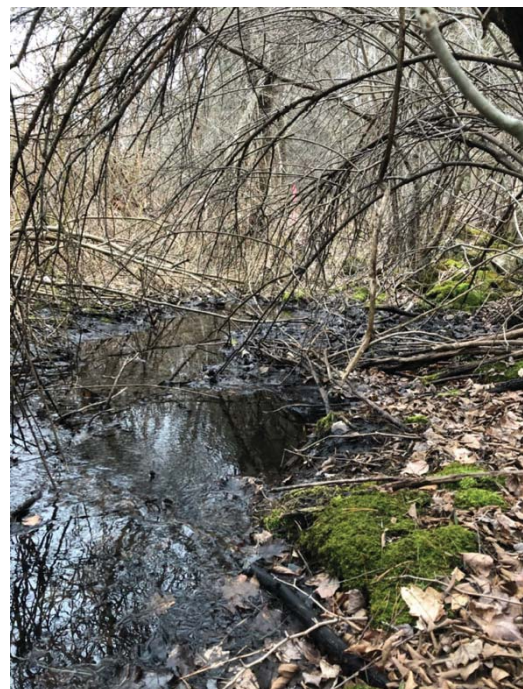
**Photo 23:** The Banks of Stream 3 can be seen merging with the gravel which the stream flows under. The dense overhanging brush makes the Banks difficult to maneuver and capture in a photo.

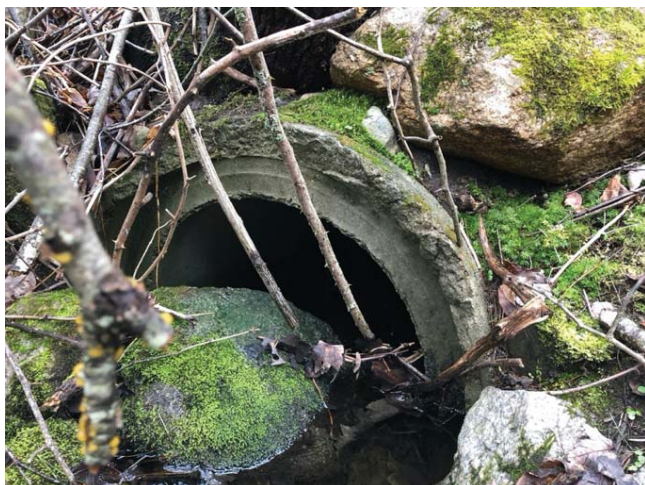
**Photo 24:** The existing conditions of the entrance to the culvert.

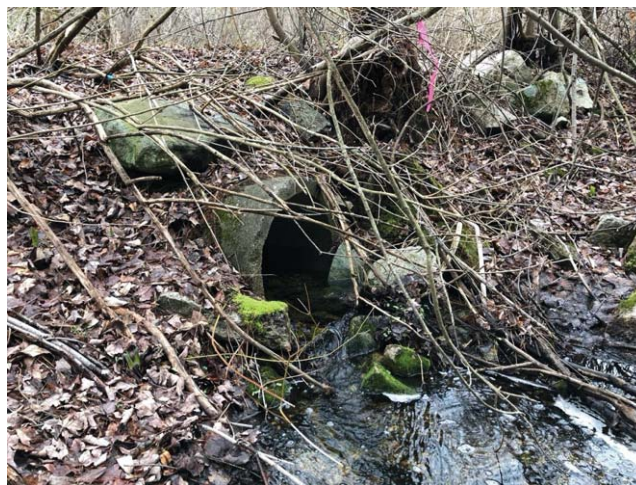
**Photo 25:** The existing conditions of the exit side of the culvert.

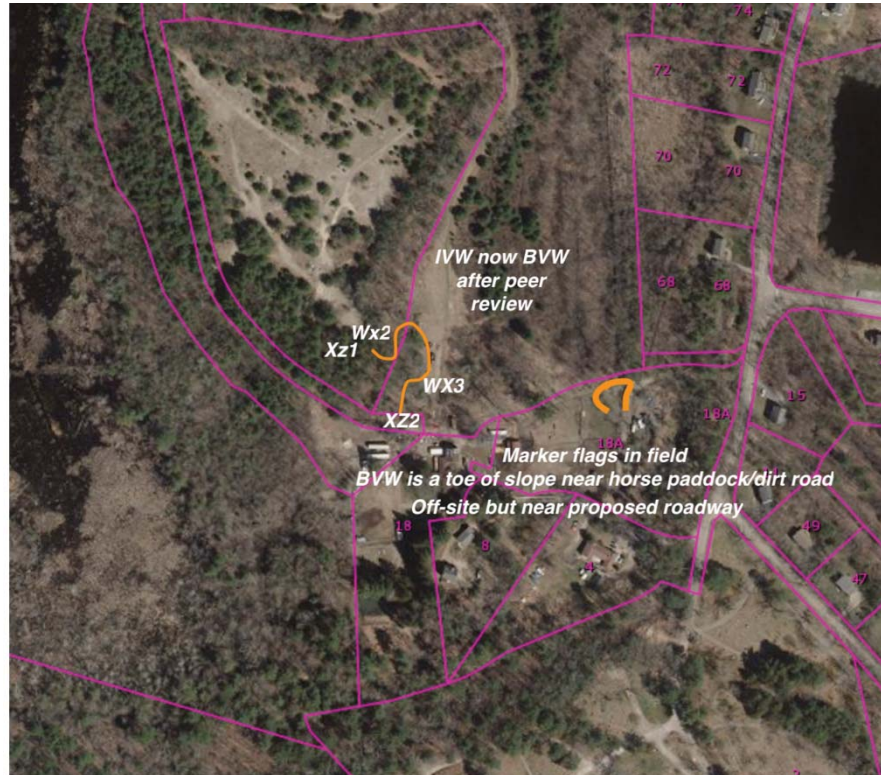
**Sketch 2:** The BVW shown in the sketch is flagged XZ1-WX2-WX3-XZ2.

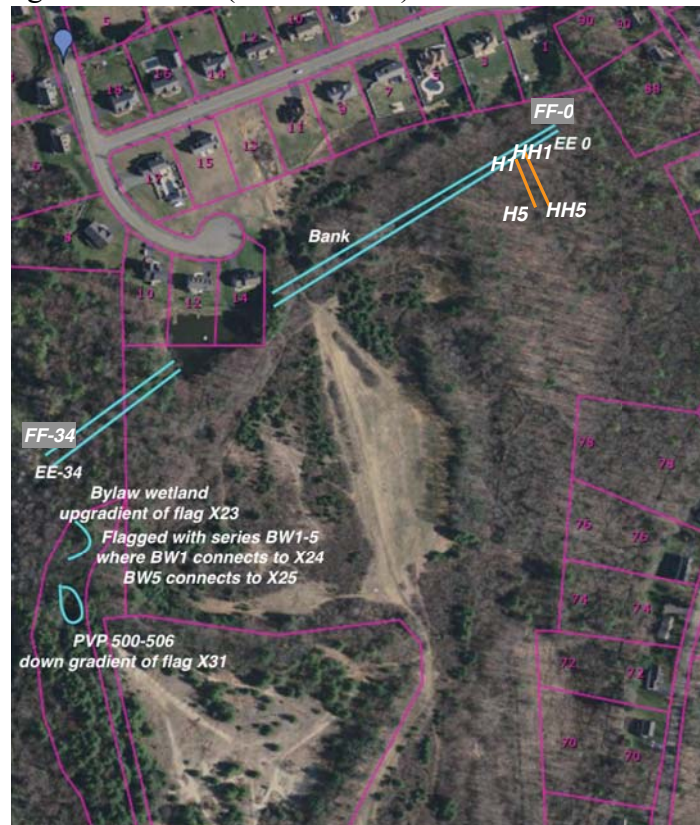
**Sketch 3:** The northerly stream Banks have been flagged with the series FF 0-34 and EE 0-34.
